Near Miss and Serious Nonfatal Accidents Metal and Nonmetal Mining

September 2013 through December 2014

NEAR MISS AND SERIOUS ACCIDENTS

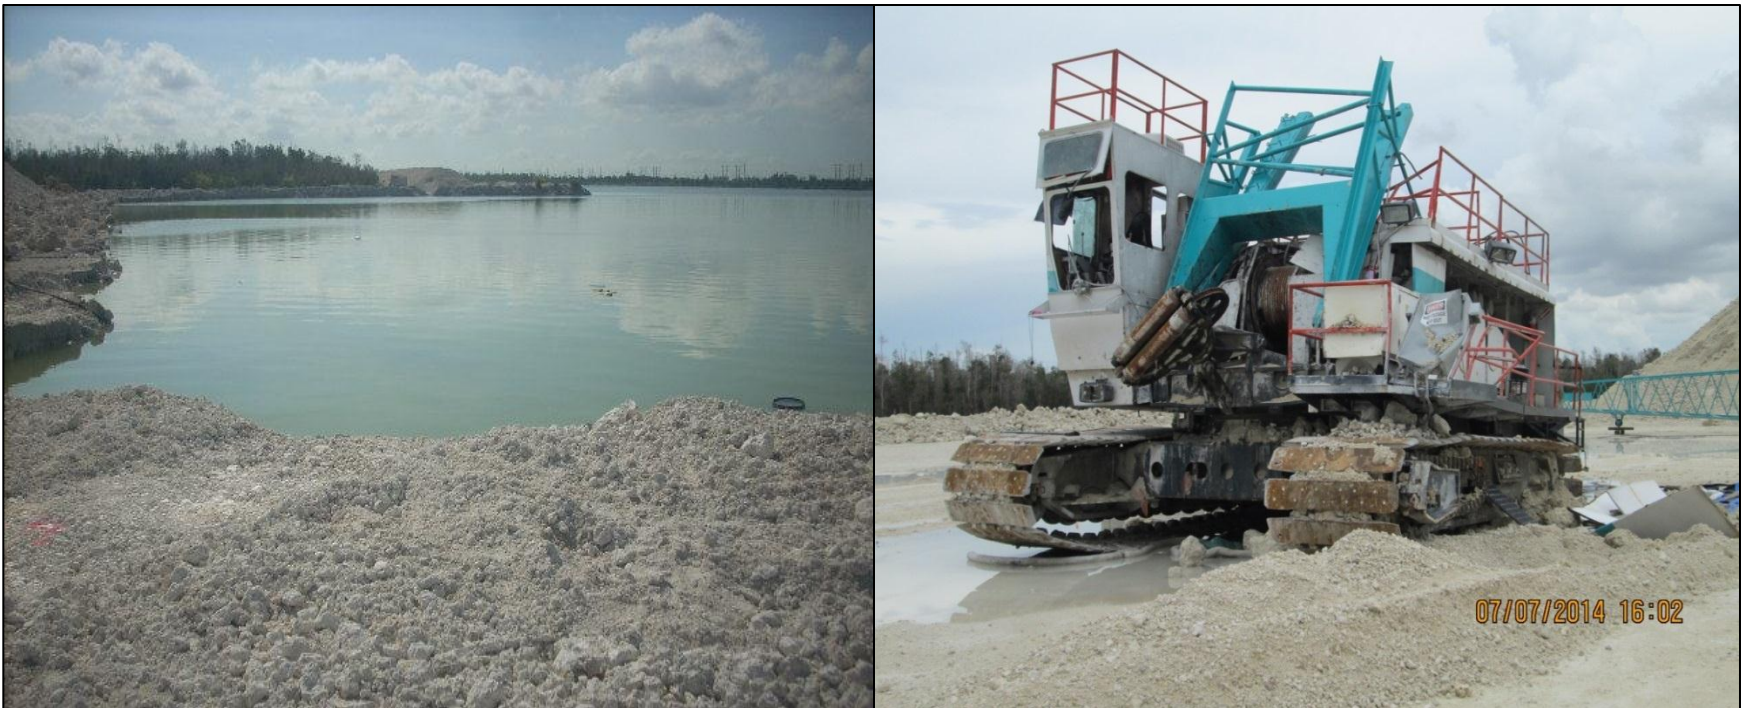
June 6, 2014

Crushed & Broken Limestone mine (wet mining site) – A dragline slid into a water filled pit when the ground gave way beneath it. The dragline operator swam to safety while the dragline submerged. No injury occurred to the dragline operator. However, the potential for drowning was high because as equipment submerges eddies are created that can pull a person down with the machine.

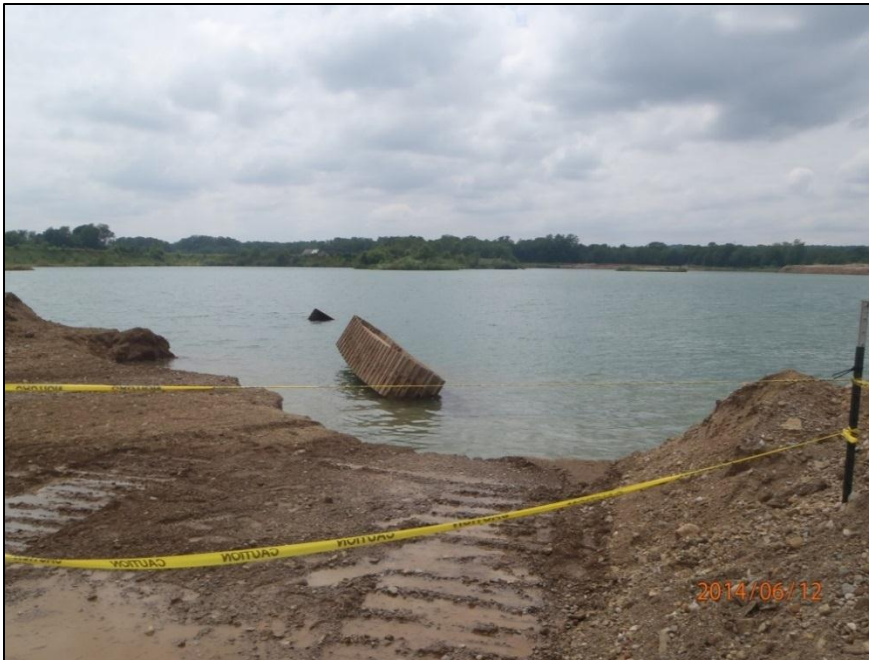
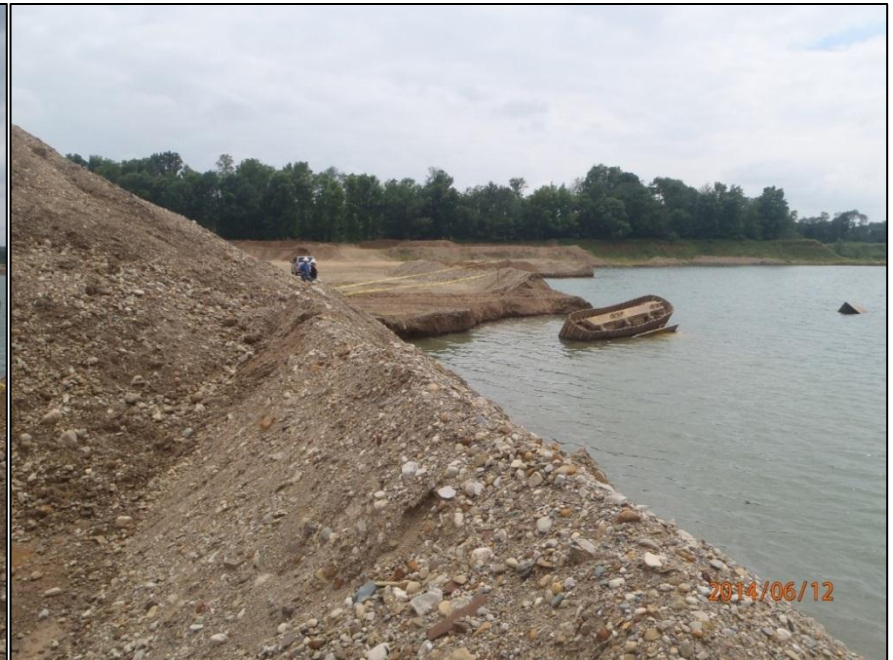
June 13, 2014

Construction Sand & Gravel mine – A Cat 245 excavator parked near the edge of the lake fell into the water when the bank gave way. The miners were away at lunch. Had the accident occurred earlier, the excavator operator might have drowned.

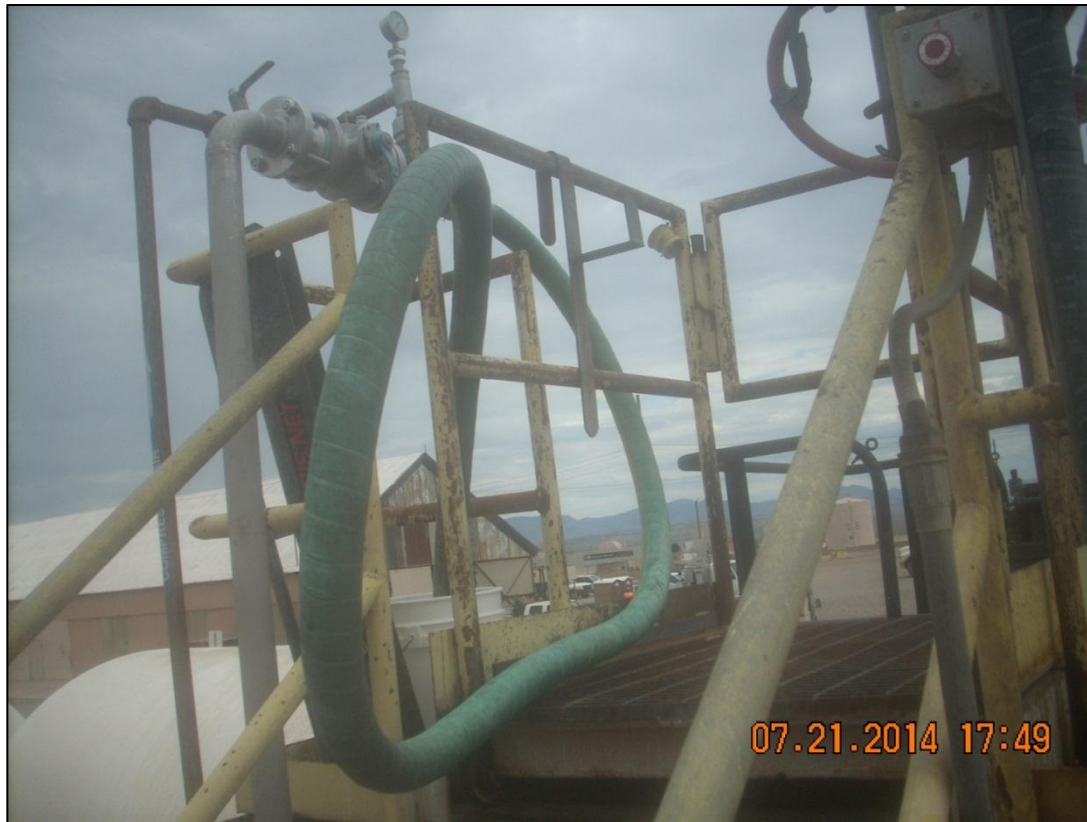
July 19, 2014

A miner suffered chemical burns when he was sprayed with sulfuric acid. The acid blew out of an unrestrained 2-inch hose when he pressurized it.

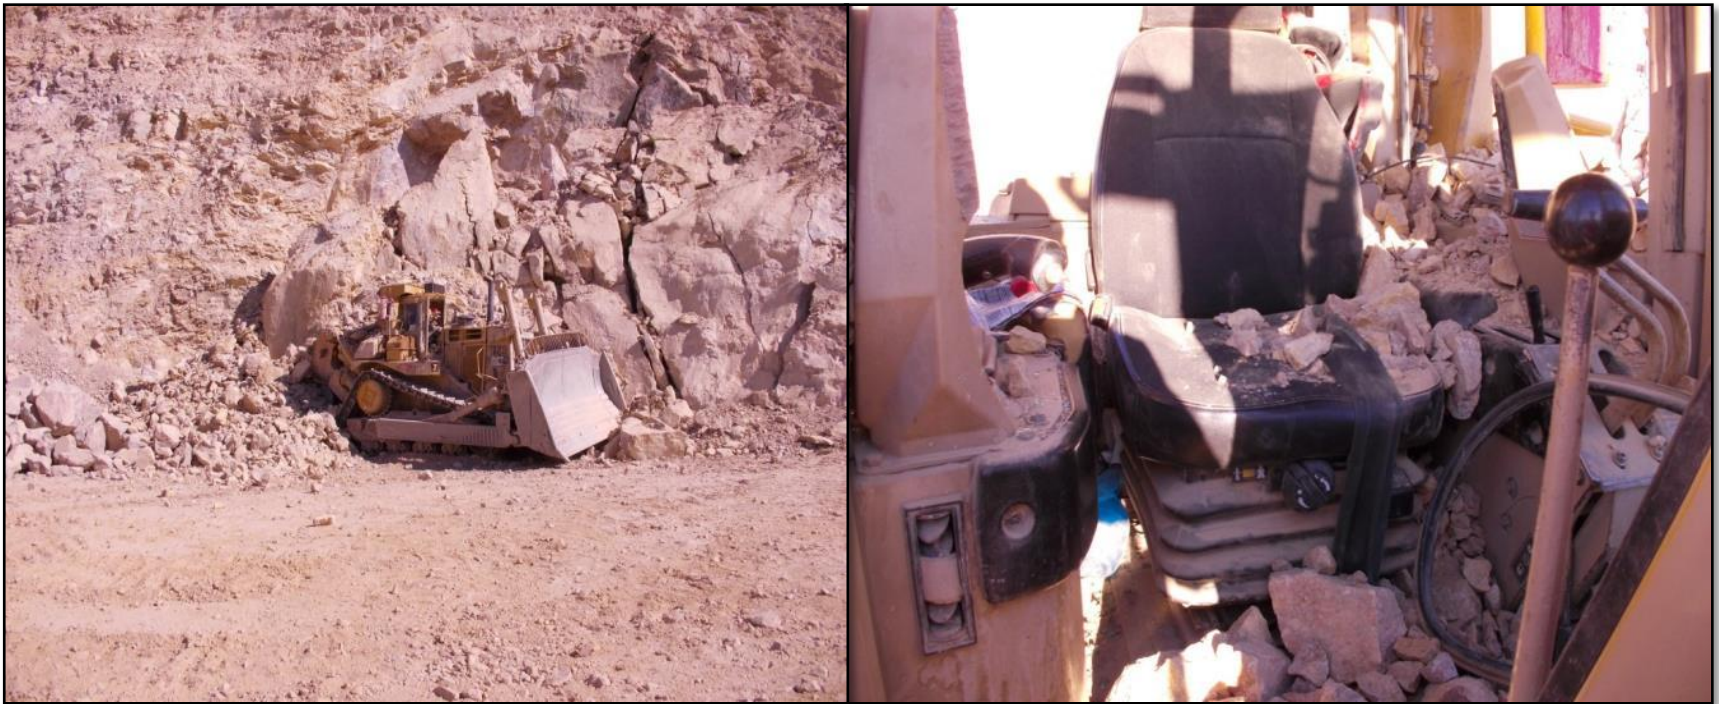
September 19, 2013

Surface Gold Mine - A Caterpillar D-10 dozer operator was cleaning material while traveling parallel along the toe of the high-wall. When the dozer hooked a rock at the toe, the highwall failed. The rock broke out the cab's glass and entered the operator's station. The operator of the dozer was uninjured.

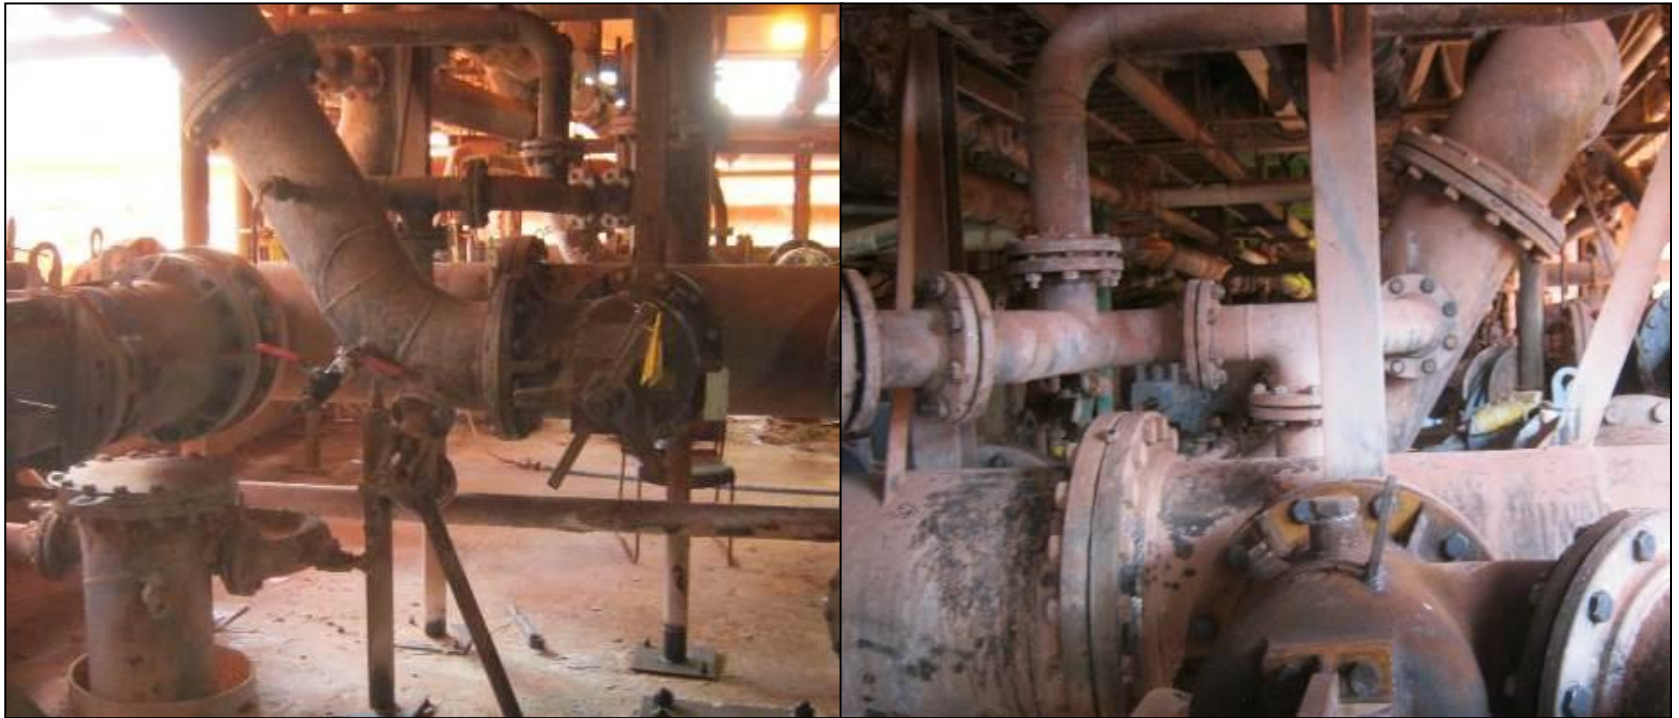
September 2014

Surface Alumina operation - A contract supervisor was burned by spraying caustic liquor while supervising the removal of a piping T-joint . The supervisor, who was not wearing proper PPE, received second and third degree burns to his back.

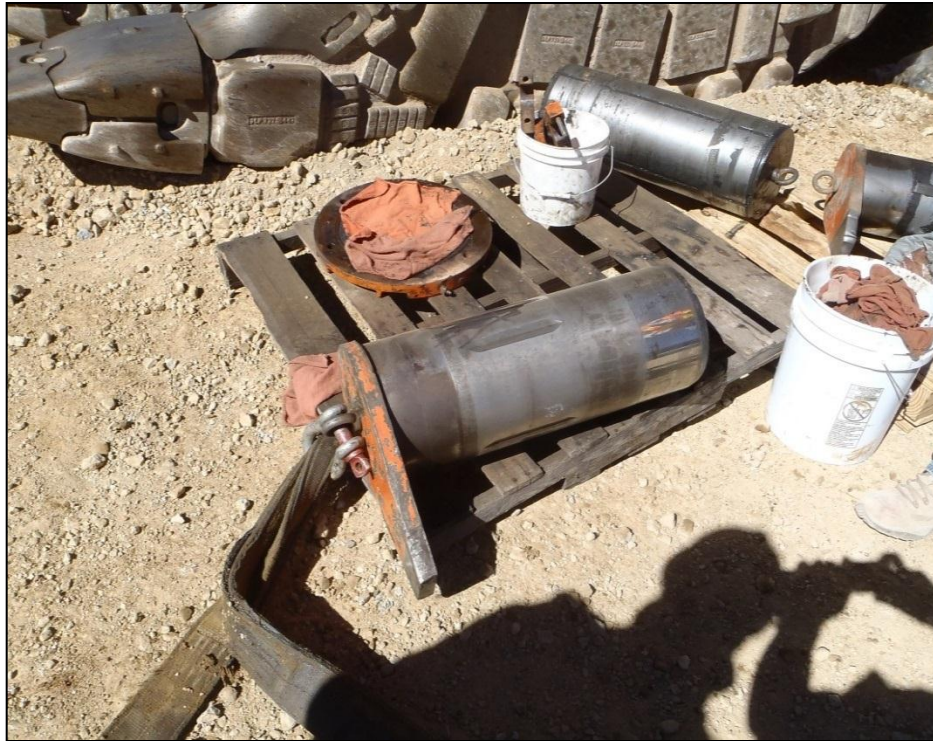
October 1, 2013

A miner attempting to remove a boom pin on a Hitachi EX500 shovel was injured when the pin suddenly shot out of its bushing and struck him in the leg, breaking his tibia. Excessive pressure was being applied to the pin by a come-along and a forklift.

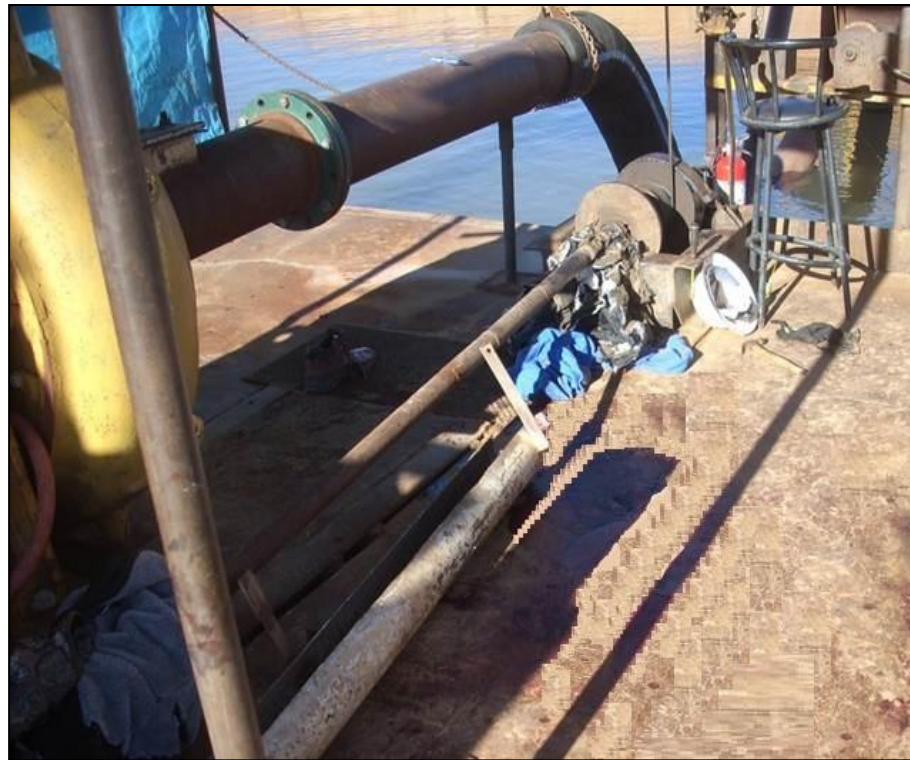
October 2014

Surface Dredging operation – A dredge operator's right leg became entangled in an exposed drive shaft and was amputated below the knee. A guard had previously been provided, but the drive shaft had been lengthened after a new motor was installed. Therefore, the guard was no longer sufficient to protect miners from moving parts.

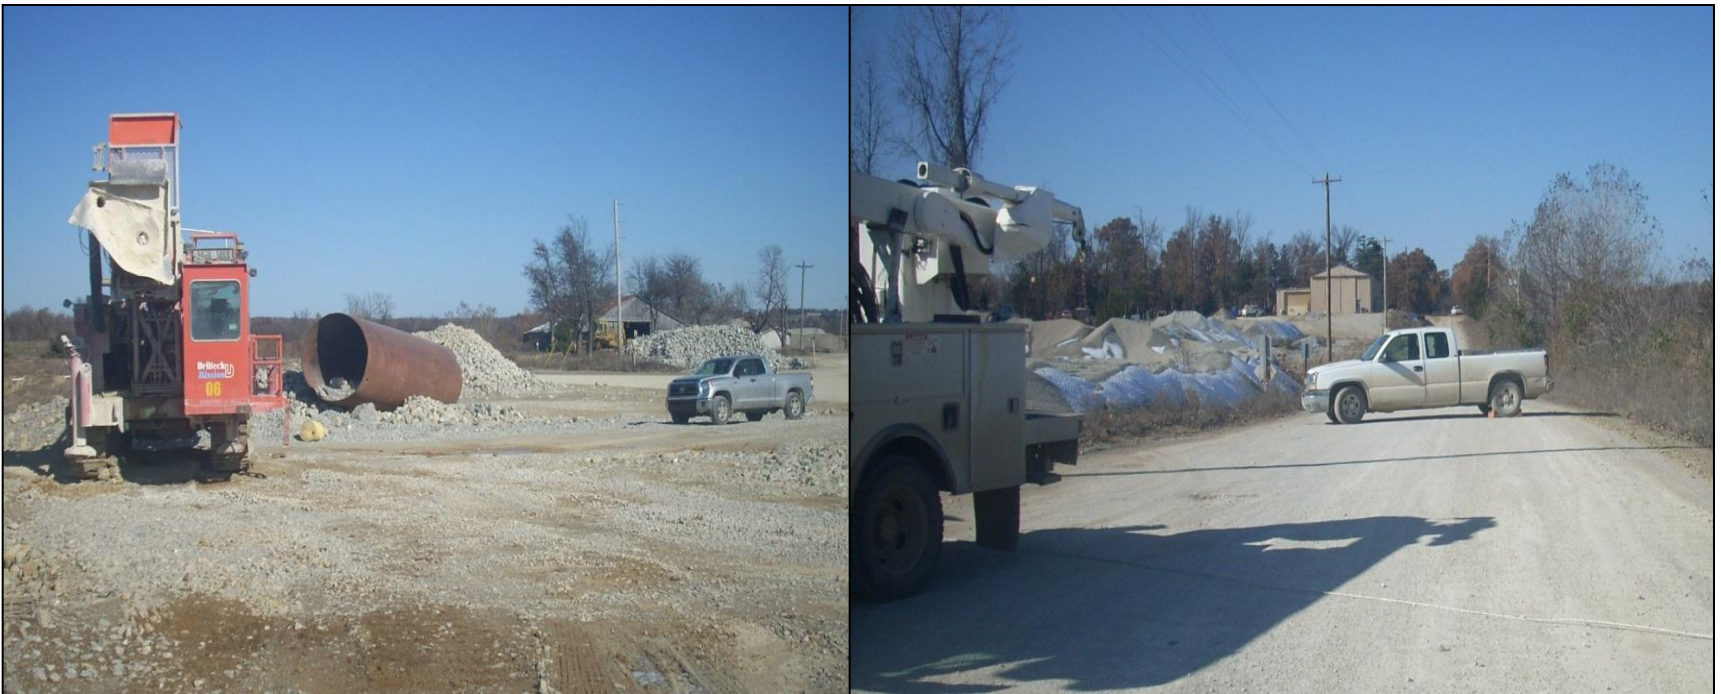
November 2014

Surface Stone operation – A drill operator parked under a 7,620-volt power line and contacted the energized line while raising the mast to service the air compressor. The operator remained inside the drill and called the mine foreman who contacted the power company and had the line deenergized. The drill operator remained inside the cab until the power company confirmed it was safe to exit.

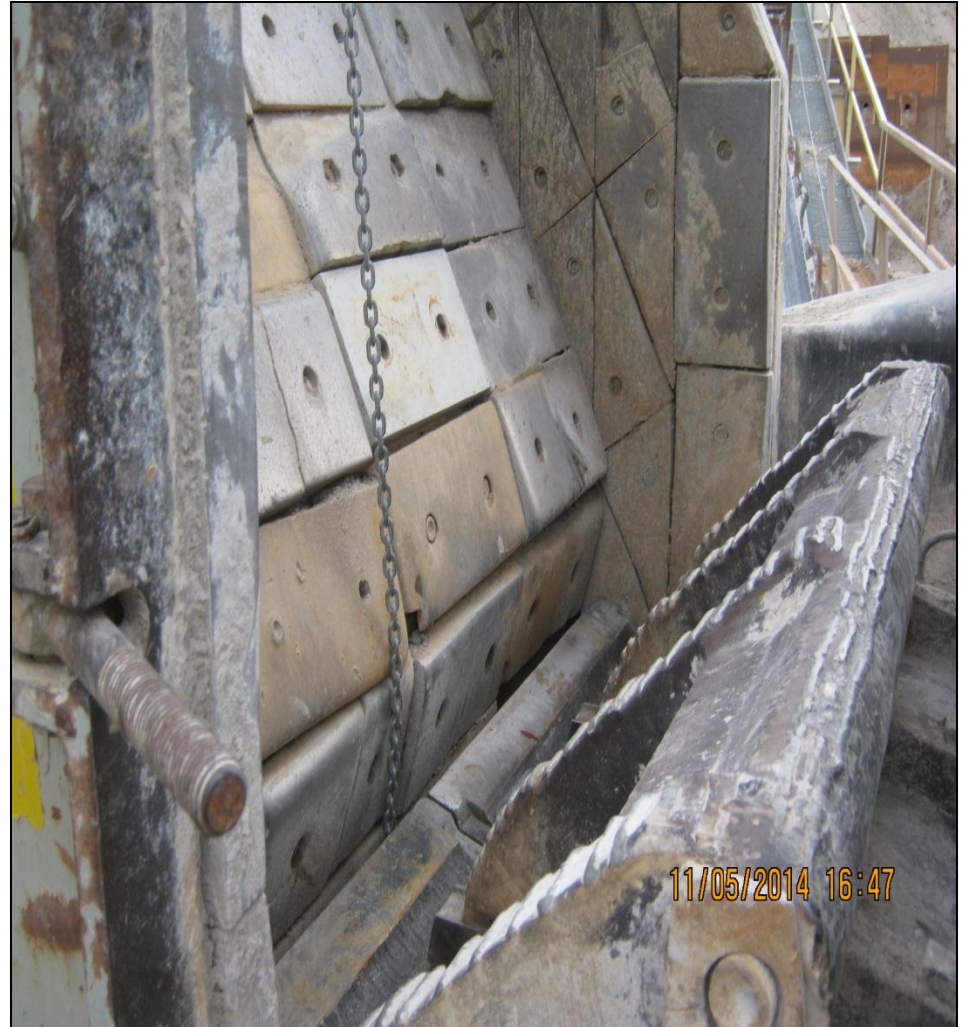
November 2014

A miner's leg was injured and the toes of one foot were partially amputated when his leg was caught between an impact crusher rotor and the wall. The wedge that was in place to prevent rotation fell out of place, causing the rotor to turn.

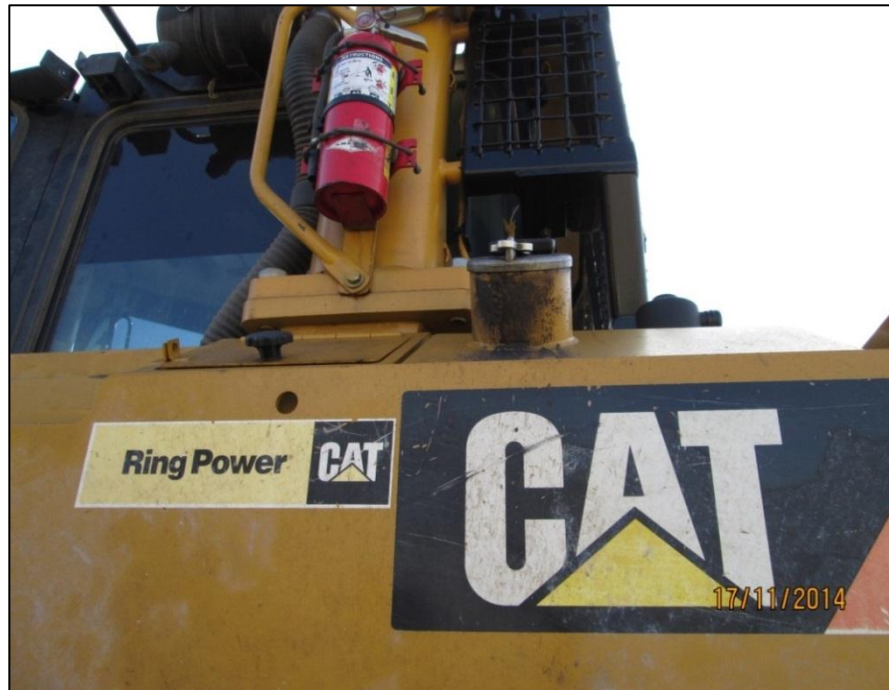
November 17, 2014

Surface Phosphate Mine – A contract dozer operator was checking the fuel level in a D8T Cat dozer by looking down the filler neck. A fuel vapor ignition occurred causing a flashback in the dozer operator's face. The employee, who was not wearing safety glasses, suffered second degree facial burns and heat burns to his right eye. The fire marshal believes the victim was smoking at the time of the flashback.

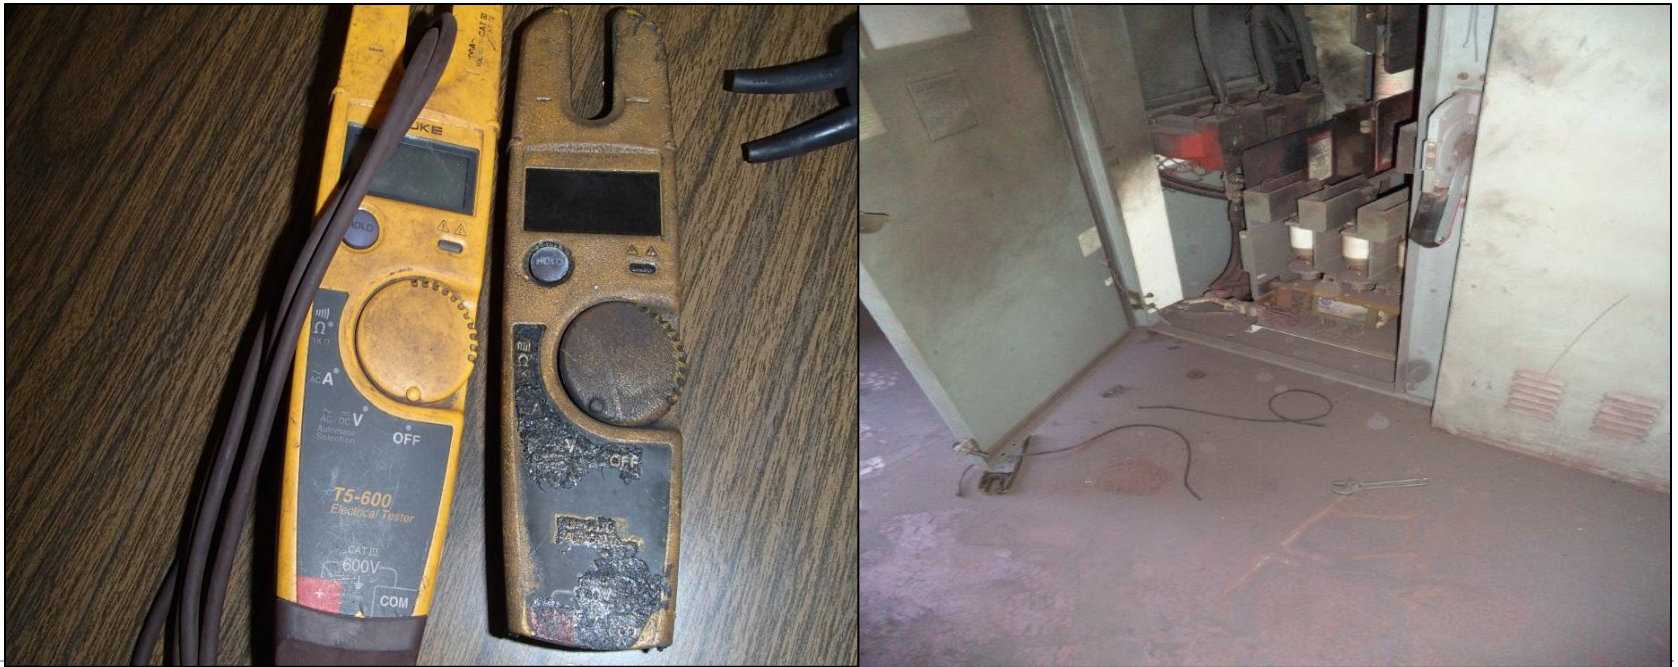
June 8, 2014

Taconite mine – A mine electrician did not lock out a 4160-volt starter/disconnect when testing a circuit with a 600-volt meter. The safety device that prevents the starter door from being opened when the system is energized had been defeated. The electrician was burned from the arc flash that occurred when he contacted bare metal conductors inside, and the meter “blew up” in his hands. The electrician, who was not wearing proper protective gear, was hospitalized with burns to his hands and face.

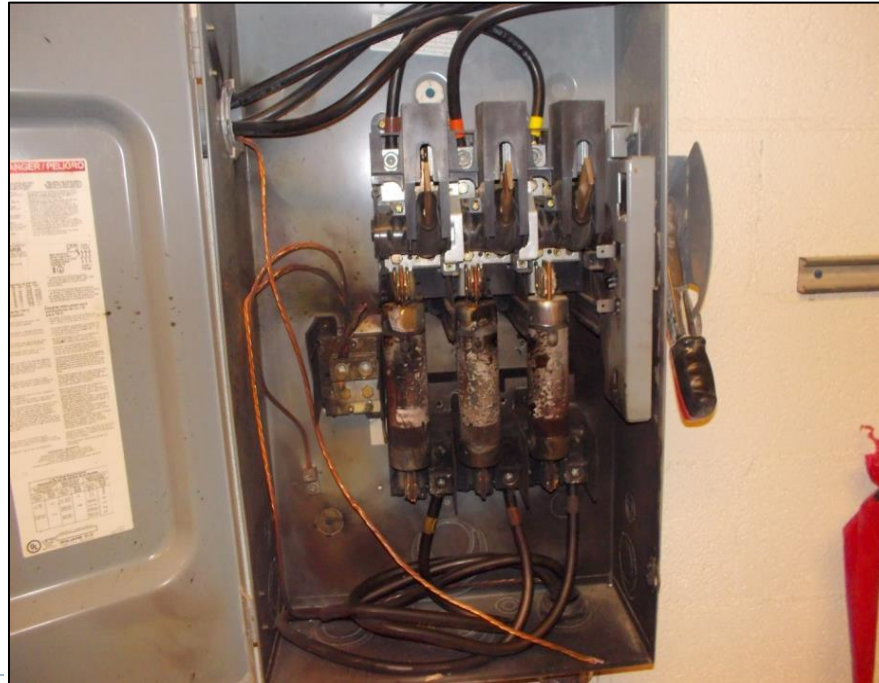
July 10, 2014

Surface Copper - A company electrician with 6 years of experience at this mine was checking ground continuity and resistance of an energized 480 volt electrical disconnect. The electrician contacted an energized 200-Amp fuse creating an arc-flash explosion. The electrician was burned on his hand, arm and face. The lack of proper arc-flash rated personal protective equipment (PPE) contributed to the seriousness of the injuries. Proper de-energizing and lockout would have prevented the accident.

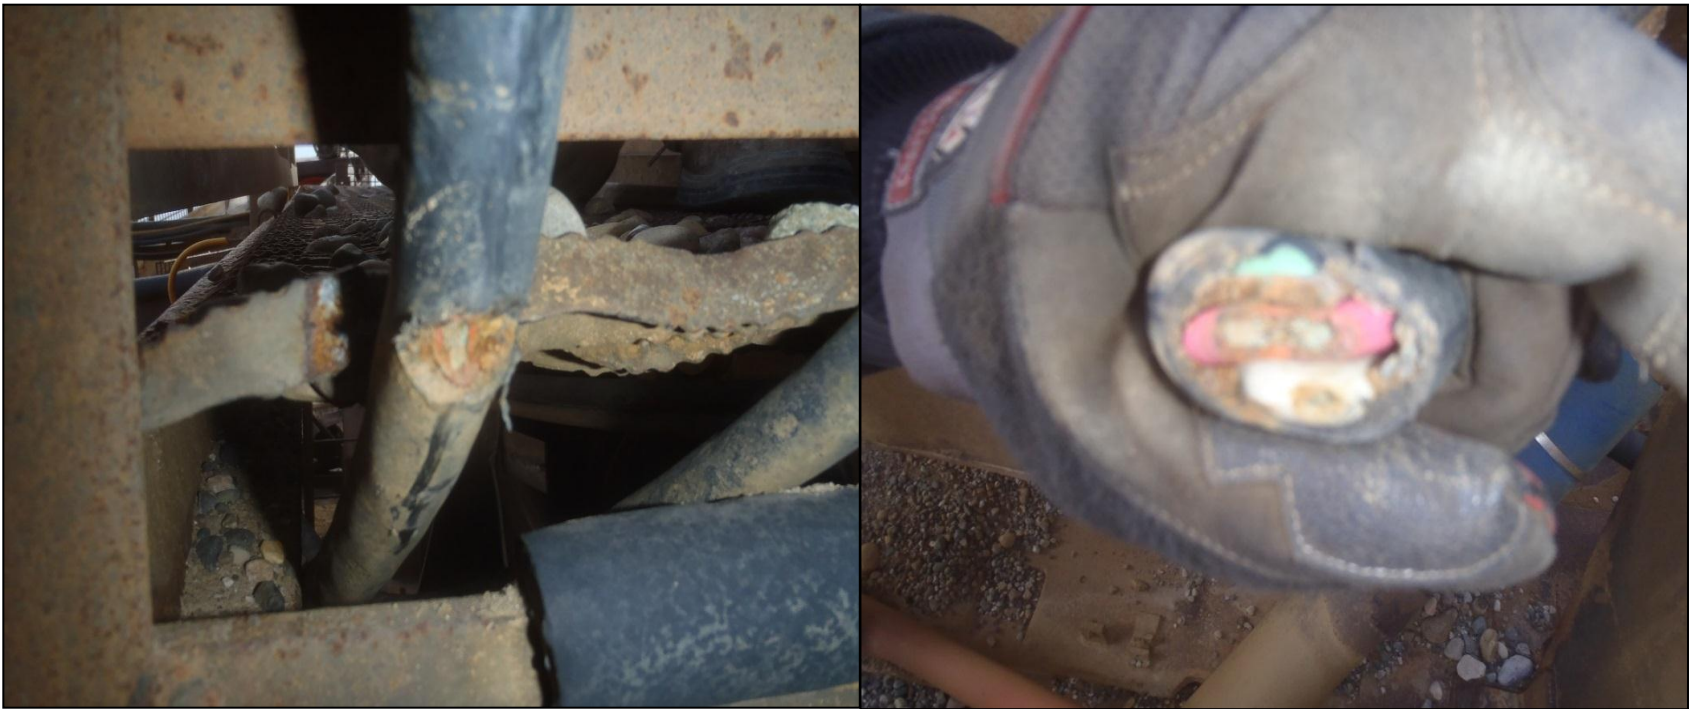
Dec. 4, 2014

Surface Sand and Gravel mine – During an inspection of the wash plant, a damaged electrical conductor was found on a screen plant and an exposed conductor was contacting the metal work platform. Despite a warning light indicating a ground fault condition, two miners continued to operate the wash plant with the ground fault present. Fortunately no one was injured.

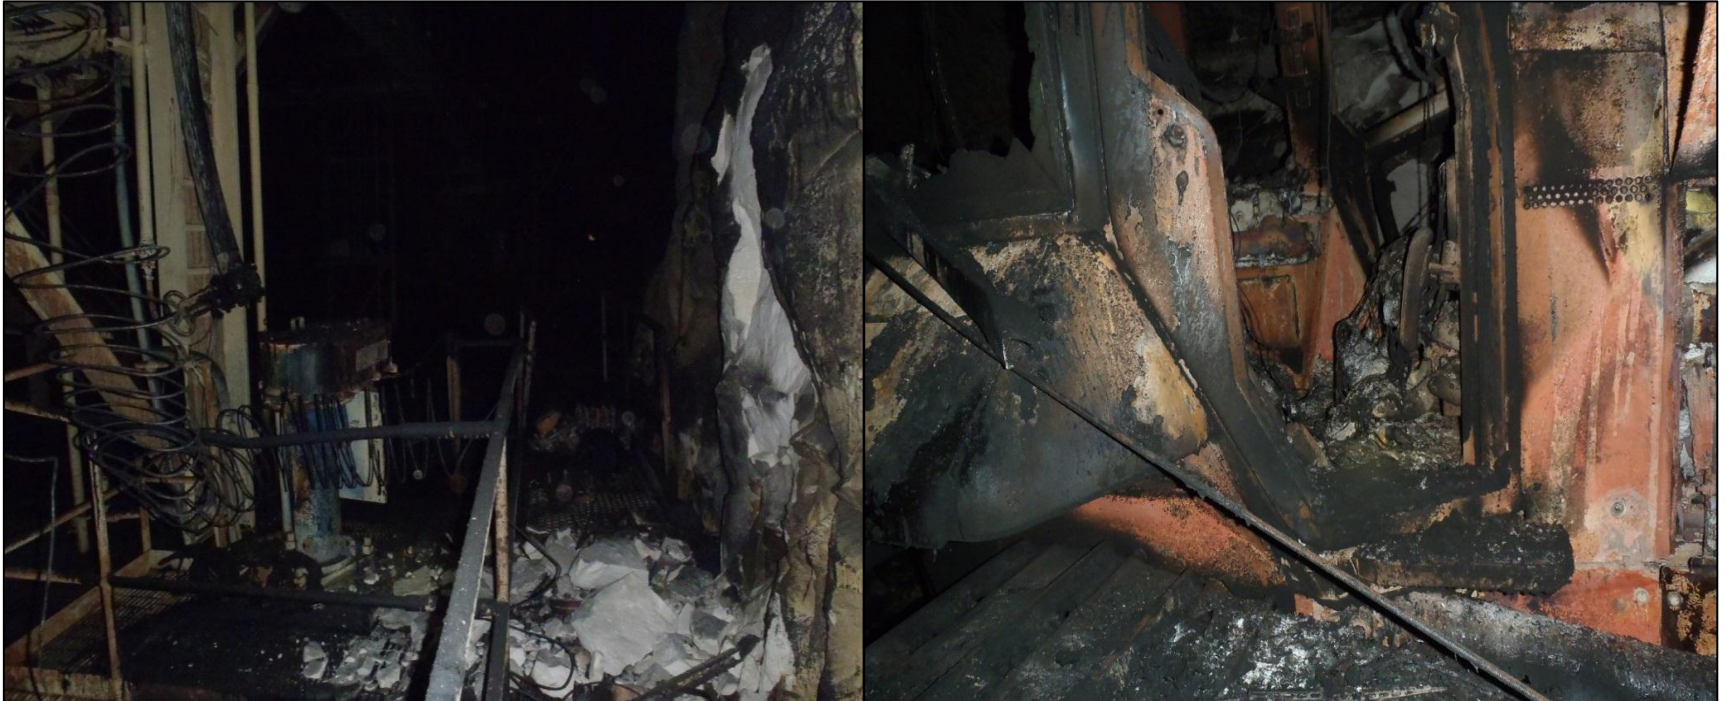
July 10, 2014

Industrial Sand mine – Mechanics were cutting a pipe on a tank at the underground wash plant when they ignited the rubber lining of the tank. The fire burned for several days, causing extensive damage to the wash plant and mine roof over the wash plant. The miners that were underground evacuated safely.

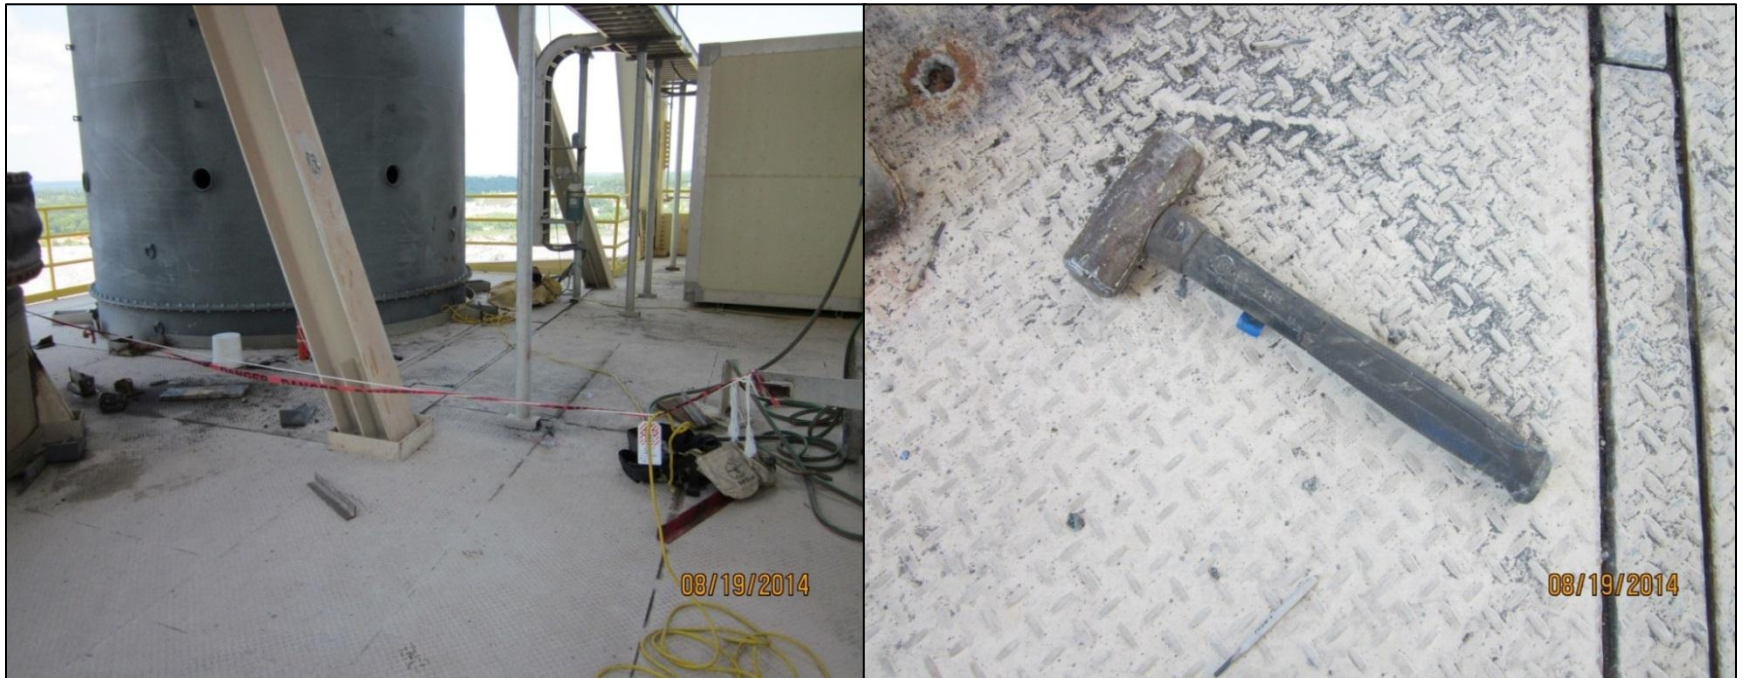
August 19, 2014

Cement Facility – A miner inside a barricaded area on the preheater tower was struck in the back by a 4-pound hammer that was accidentally dropped by a contractor working on the level above. The miner, who should not have been inside the barricade, was transported to the hospital and was released with no restrictions.

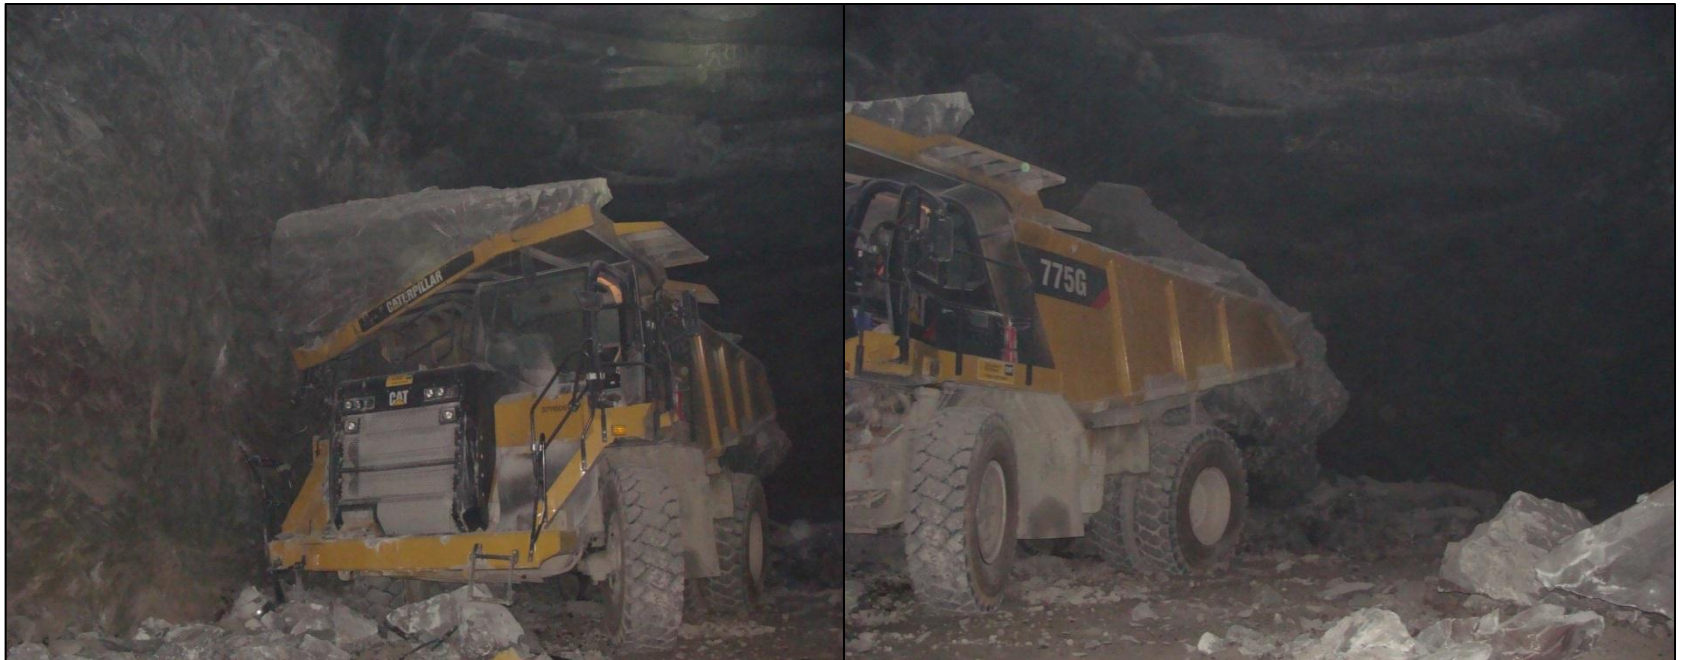
August 12, 2014

Underground Crushed & Broken Limestone mine - A haul truck was being loaded underground when a significant portion of the immediate roof above the truck fell, covering the top of the truck and the area behind it. The truck driver, who was in the cab, received medical treatment.

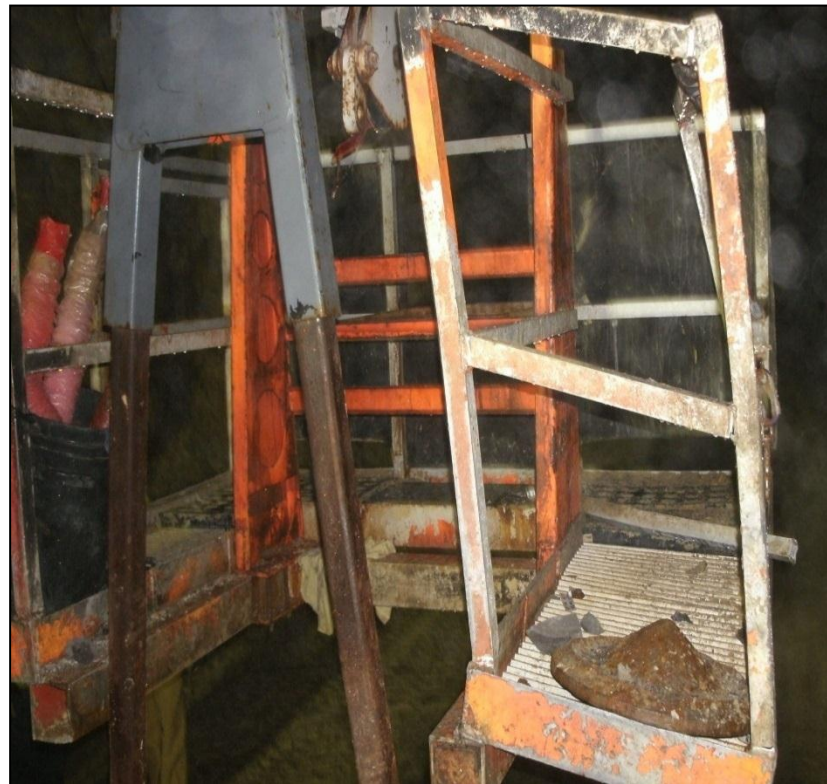
August 2014

Underground Limestone mine – An accident occurred when loose rock fell from the roof of an underground mine following a shot and struck a miner in the man basket of a blasting truck. The miner suffered fractures on his face, cracked ribs, a broken scapula, and abrasions and contusions on his back.

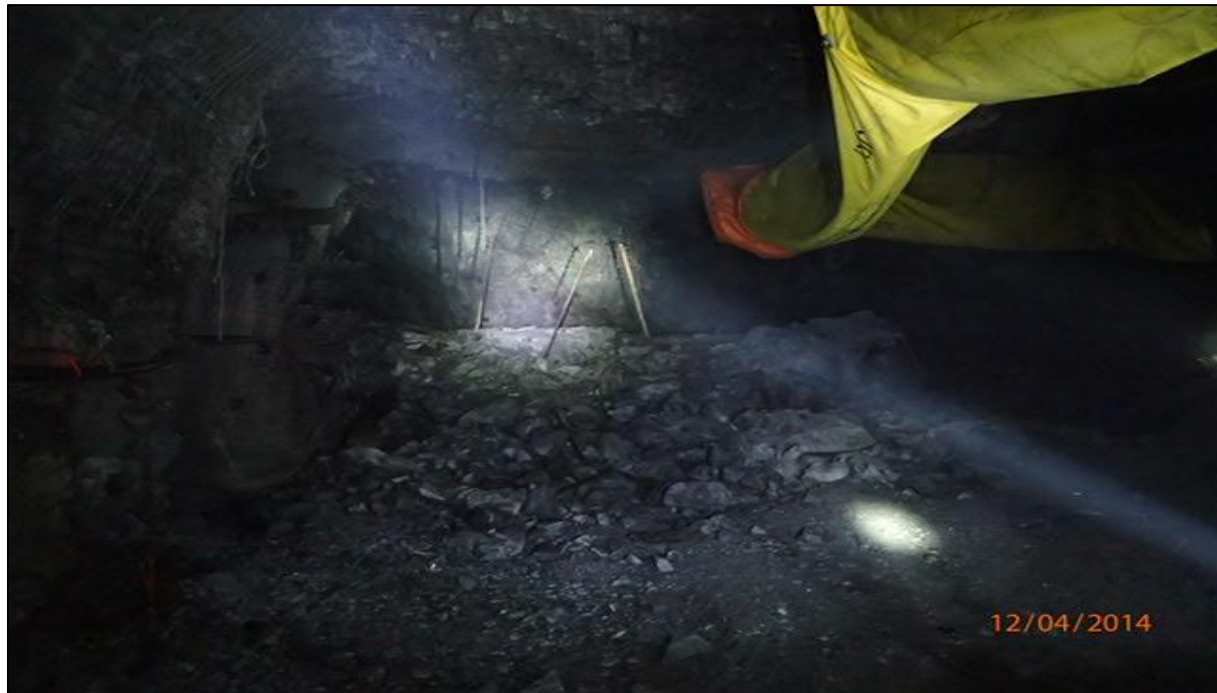
December 2, 2014

Underground Gold mine – A roof bolter working in a heading was uninjured and was able to exit safely after approximately 370 tons of material fell from the 15-foot high back at an intersection 200 feet from his work position. Longer bolts, a tighter bolting pattern, and/or timbering may have prevented this ground fall and should be considered for use in intersections and areas with unknown geology.

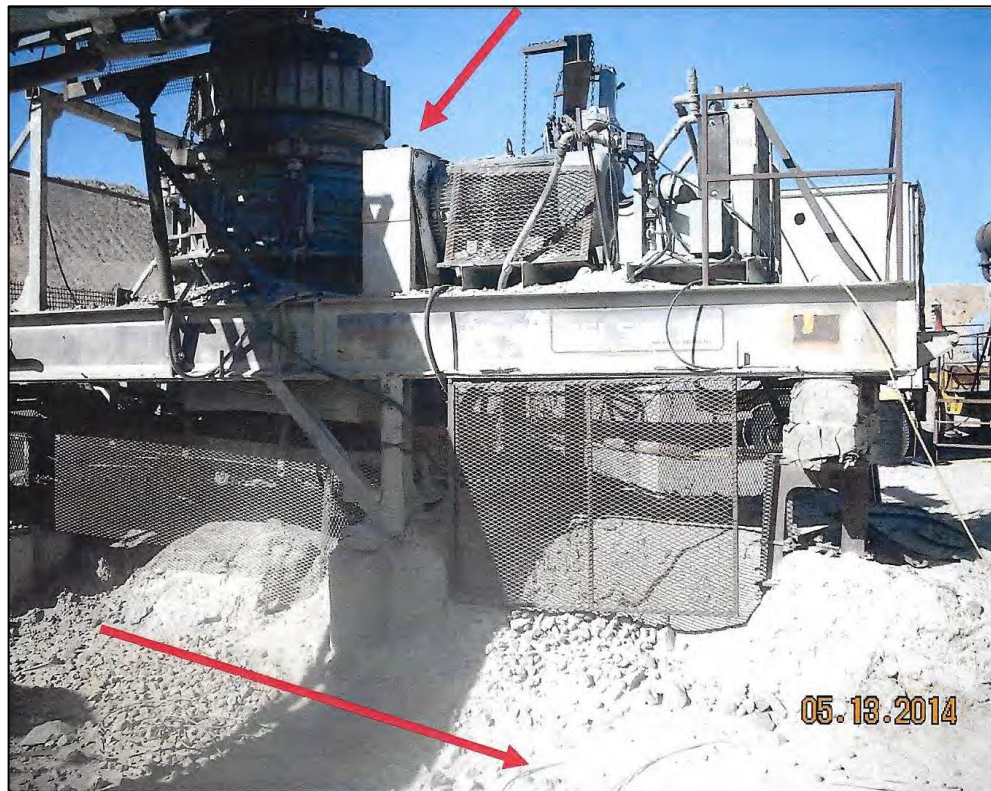
May 13, 2014

Surface Sand & Gravel mine - A maintenance mechanic standing on the top of a gear box fell approximately 11 feet to the ground below and received permanently disabling injuries.

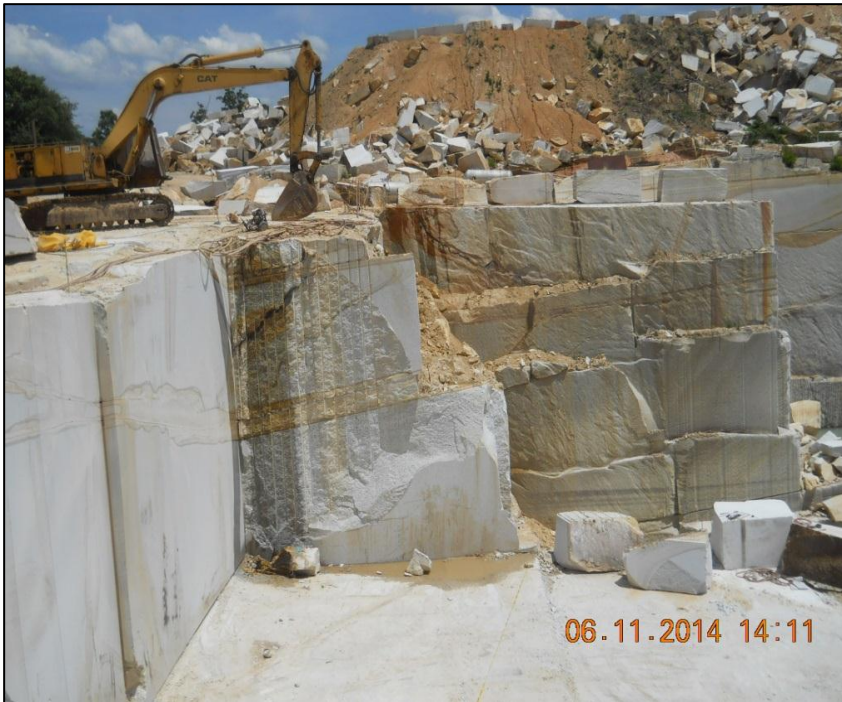
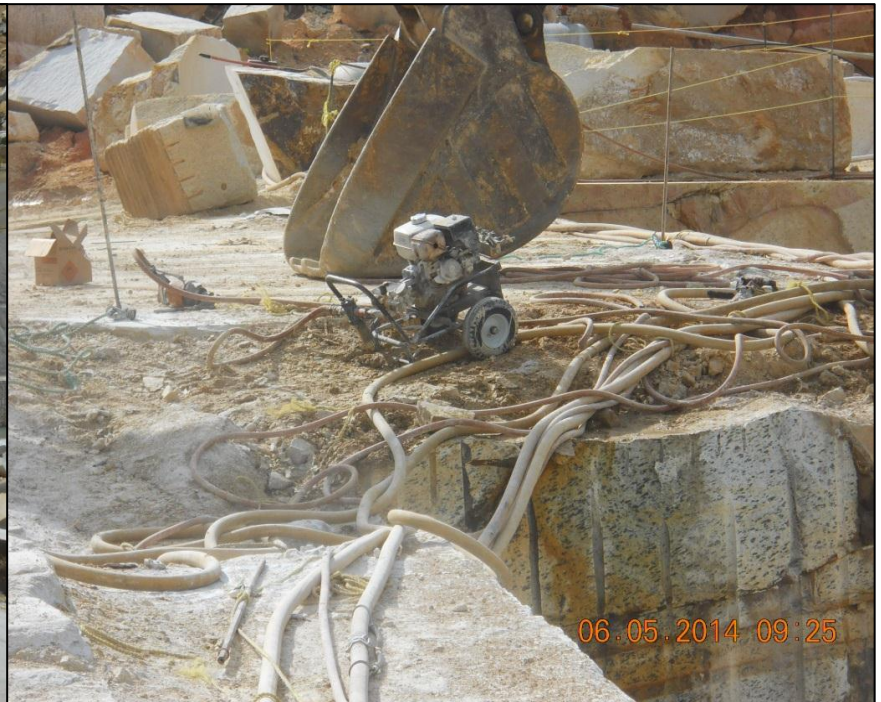
June 4, 2014

Dimensional Stone - A miner fell 34 feet to the granite floor below while using a 10-pound sledge hammer to break a rock free from the edge of the quarry. The miner was not using fall protection. The miner survived, but sustained serious injuries.

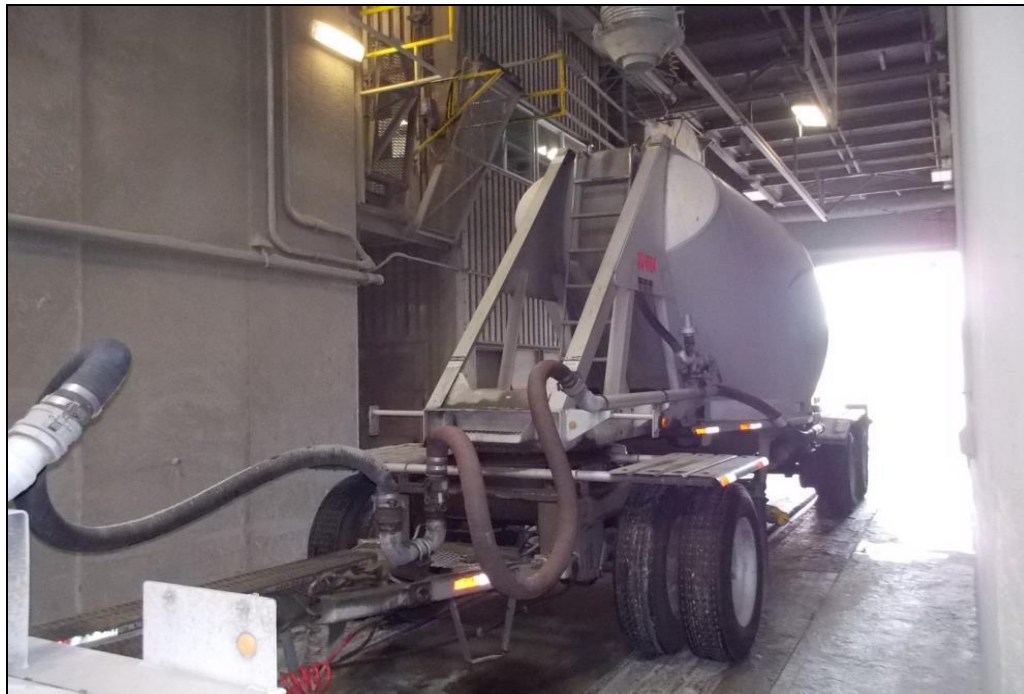
July 23, 2014

Cement Plant - A loaded cement tractor trailer pulled forward in the loading area when a worker noticed he had forgotten his cell phone. A trainee truck driver climbed on top of the bulk cement trailer without using fall protection. The trainee hit his head on the overhead chute and fell approximately 15 feet onto an uneven steel platform below. There were no signs warning of overhead dangers. Had he been wearing fall protection equipment, he likely would have received only minor injuries.
